An Interpretative History of the Ginninderra Blacksmith Shop: From Inception to the Present Day (c.1859-2011)

By Angela Bremers (3037322)

Cultural Heritage Research Project Unit: 7962

INTERPRETATIVE HISTORY: GINNINDERRA BLACKSMITH SHOP

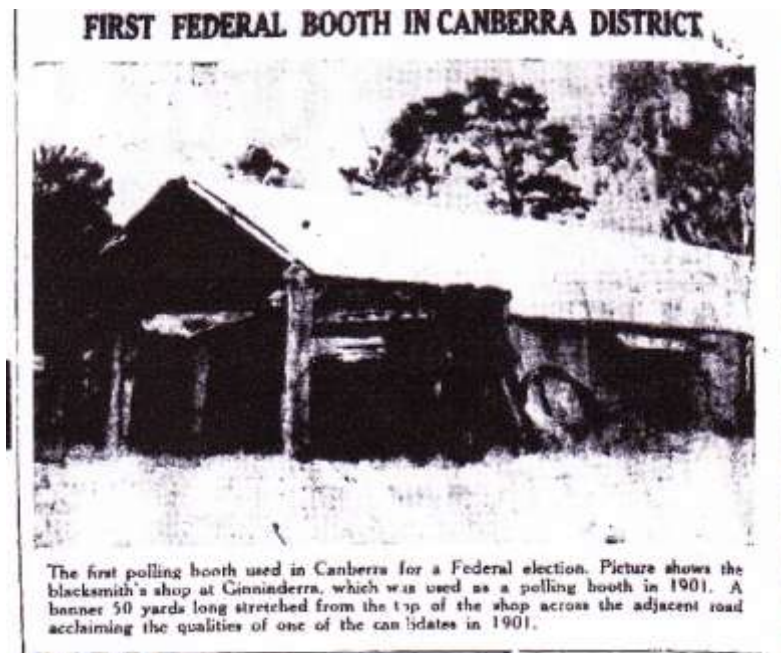
Figure 3: Oldest known photograph of the Ginninderra blacksmith Shop, approx. 1949

The Canberra Times photograph of the Ginninderra Blacksmith Shop is stated to be the oldest known photograph of the Blacksmith Shop (Dowling & Ireland, 2011, p.7⁵). This is true as other photographs one captioned "side view of George Curran's blacksmith shop and house" does not state if it is in Bungendore or in Ginninderra (Maher, c.1981, p.27?). The photograph does not resemble the Ginninderra Blacksmith Shop in its current state. Another photograph captioned "George Curran and his nephew Henry Curran – blacksmiths, Ginninderra" is also captioned in another book as being "George Curran with nephew Harry Curran at Bungendore Blacksmith's Shop" (Maher, c.1981, p.27?; Warman, 1981, p.28). Another depiction of Henry Roland Curran was in Eirene Mort's *Old Canberra Sketchbook of the 1920s* published posthumously in 1987 (Mort, 1987, p. 67; Biography – Eirene Mort, Australian Dictionary of Biography, viewed 2011). The book displays one sketch of Curran working on a horseshoe at his anvil (figure 5) (Mort, 1987, p. 67). Something that looks like a heavy hammer or sledge is in the doorway (Mort, 1987, p. 67). The doors are made out of wood and the roof appears to be made out of corrugated iron supported underneath by wooden slabs. Curran is depicted with his face down concentrating on the horse shoe on the anvil.

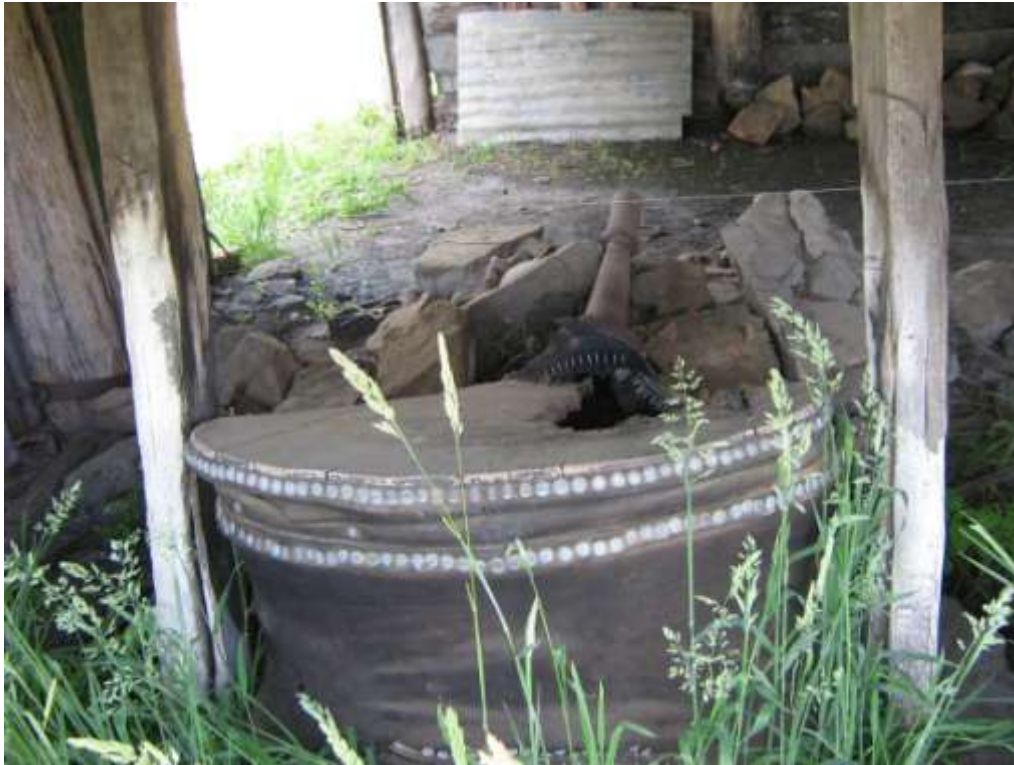
Figure 13: Bellows

The interior consisted of a forge, work bench, horse shoeing area, hearth, storage space where farm equipment was stored, couch, bellows area, wheelwright area and a grinding stone (see figure 10) (Dowling, 2003, p.12). Eirene Mort's sketch mentioned earlier gives a rough idea of what the forge looked like in 1923 showing that it was made up of stone, with a wooden door (see figure 5) (Mort, 1987, p.67). The forge was dismantled sometime after the blacksmith shop had been abandoned (Dowling, 2011, p.20). During a site visit in September 2011 there was a small pile of stones backed up against the wall (see figure 13).

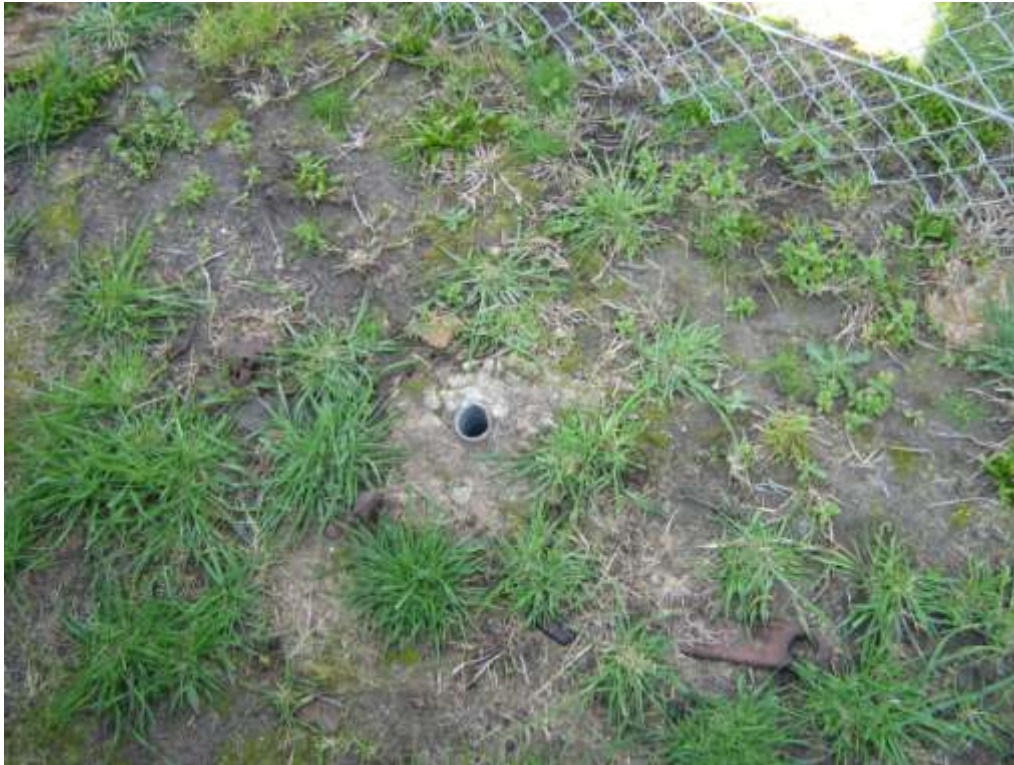
Figure 19: Metal subterranean hollow poles

The artefacts found during the Canberra Archaeological Society survey and artefacts found in situ during visits by the author of this report show the nexus between work and home life (Besant & Avery, 1996, p.25). The cups, a piece broken off a plate demonstrate work connections with home, unless the two artefacts were stored there after the blacksmith shop had been abandoned. Most of the tools have been removed; however, the general structure of the Blacksmith Shop is still intact. The different wheelwrighting, farriering and blacksmithing tools are also evident of the work required of a blacksmith in a rural farming village (Bartlett, c.1980, p.1). The awning, work bench and horse shoeing area no longer exist (see figure 10) (Dowling, 2003, p.11). There are hollow metal poles stuck in the ground barely above ground level surrounding the Ginninderra Blacksmith shop that might indicate that the building used to be larger (see figure 19).

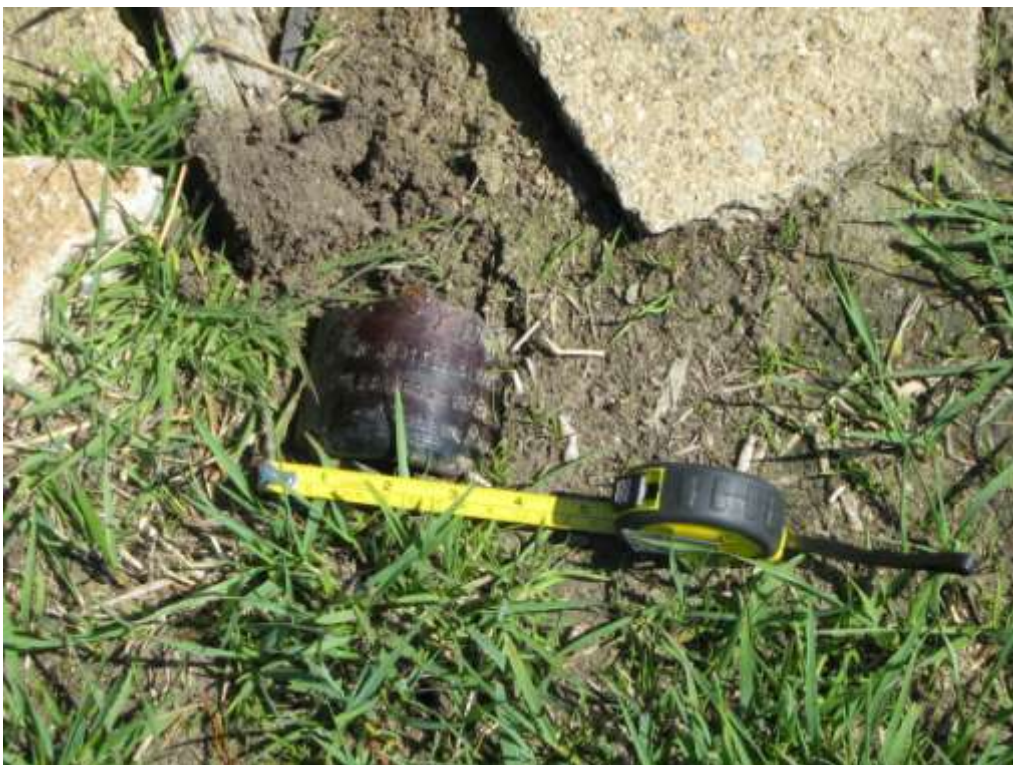
Figure 22: Broken Reschs Limited beer bottle. Please note that the measurement is in inches.

One artefact still located on the site was the bottom half of a beer bottle embedded in the ground with the words:

The bottle seems to be a beer bottle from one of Edmund Resch's breweries in New South Wales (Walsh, c.1988). It is not clear when "Reschs Ltd" came into existence but, Edmund Resch owned the Sydney Allt's Brewing & Wine and Spirit Co. Ltd by 1897 and the New South Wales Lager Bier Brewing Co. Ltd by 1900 (Walsh, c.1988). He was renowned for his skill as a brewer (Walsh, c.1988). The beer bottle may have belonged to anyone who went to the shop or Henry Roland Curran who was noted by his surviving granddaughter that he sometimes drank alcohol (McAppion in Maher, 1981, p.32). The name Reschs Limited was probably used by Edmund Resch and not his brother Richard Frederick Edward Nicolas with whom he bought two drink factories (Walsh, c.1988). It appears that the Allt's Brewing & Wine and Spirit Co. Ltd was in Sydney hence Resch coming to live in Sydney while he managed it for the previous owner (Walsh, c.1988).

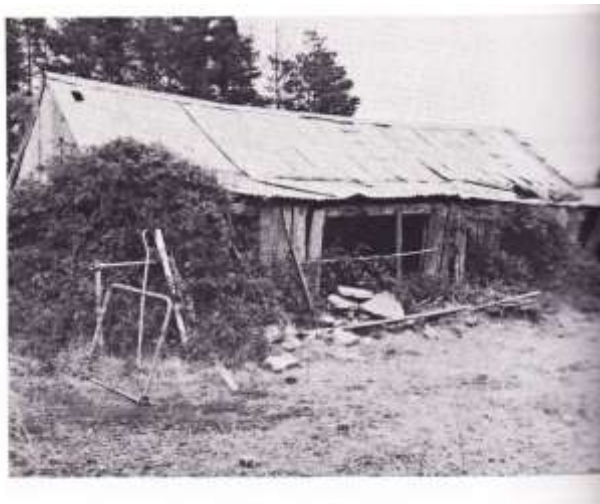
Figure 27: Sites of Significance photo of the "Northern side of the Ginninderra Blacksmith Shop". c. 1988. The site has improved since then.

The Ginninderra Blacksmith Shop was realised as an important part of the history of the ACT as early as 1988 when the National Capital Development Commission included the site in the Sites of Significance in the ACT, volume three (Sites of Significance in the ACT, 1988, pp.24-26). The book also shows that the site had no protective fence and was covered in weeds (p.24). The posts were leaning and the artefacts were exposed to the elements (see

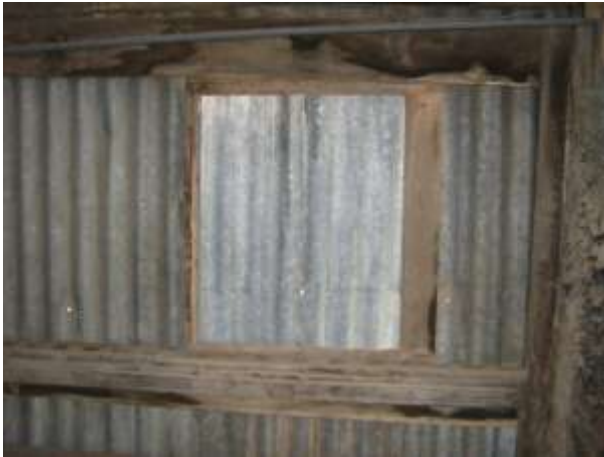
Figure 28: Part of a metal rod stabilising the structure.

A conservation plan was published for the National Trust by Dowling and Cosgrove in 2002 noting the state of deterioration and stating that the site should be restored to its 1930-1940s state (Cosgrove & Dowling, 2002, p.31). Since the 2002 Conservation Management Plan the structure has been stabilised and reinforced by metal rods (Dowling & Ireland, 2011, p.3). Weeds have been cleared; a security fence has been established around the site and an interpretative sign has been established outside the fenced area (see figures 28 and 29, evident on site visit in September 2011).
